CASE STUDIES

Conjet Robot repairs frost damaged water channel

Specialist German hydrodemolition contractor Krüger Wasserhochdrucktechnik, using its Conjet Robot 360 high pressure water jetting machine, has successfully assisted in the very unusual and tricky repair to a steep, new cooling water feed channel at the country's Boxberg coal fired power station.

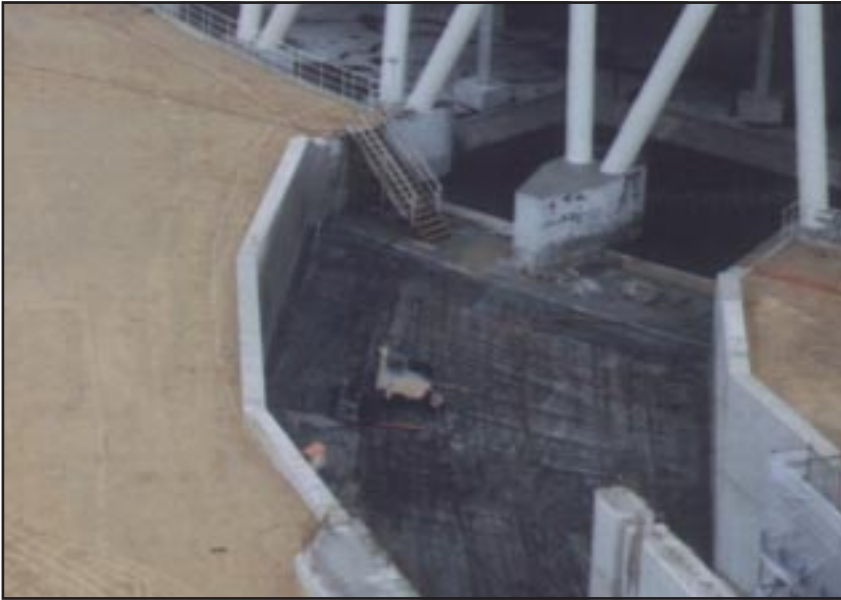
The Conjet Robot is working on the cooling water feed channel.

The Robot, suspended from a winch anchored at the top of the 45% inclined curved channel, systematically removed a layer of reinforced, water resistant concrete from the entire surface which had been badly damaged by an unexpected and very sharp frost during casting.

top and in the centre of the channel with a steel rope running down and fixed to the Robot. This simple suspension system enabled the self propelled Robot, pivoting on the anchored rope, to make traversing radial cuts across the concrete channel. After each pass the Robot was lowered on the winch to make the next adjacent cut with the cycle repeated to the channel bottom.

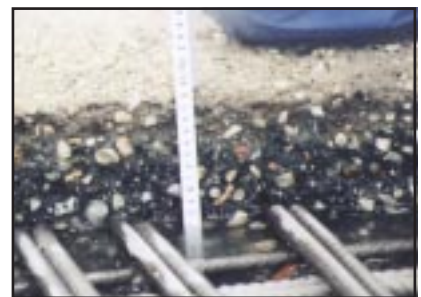
The steep, flat bottomed channel, designed to take water from the base of the power station's cooling water tower back down into the pump house for recycling, is just 21m long. It is 25m wide at the inlet and gradually tapers down in a steep, shallow curve to 18m at the discharge. The 45% sloping channel has a heavily reinforced 1.5m thick base and Hochtief and Bilfinger & Berger intended casting the complete channel base in one continuous pour. But as the contractor was nearing the end of the pour the air temperature suddenly and unexpectedly dropped to -8°C. Hochtief and Bilfinger & Berger had no option but to continue and complete the casting. But the combination of the rapid fall in temperature and very strong biting winds caused extensive frost damage to a depth of 40mm over the channel's entire concrete surface.

The damaged concrete was too weak to cater for the flow of water so Hochtief and Bilfinger & Berger, working for client and power station owner Arge Rohbau Boxberg, had to remove the spoiled layer prior to placing a complete new overlay. The client insisted that concrete had to be removed to a depth of 25mm below the upper layer of reinforce-

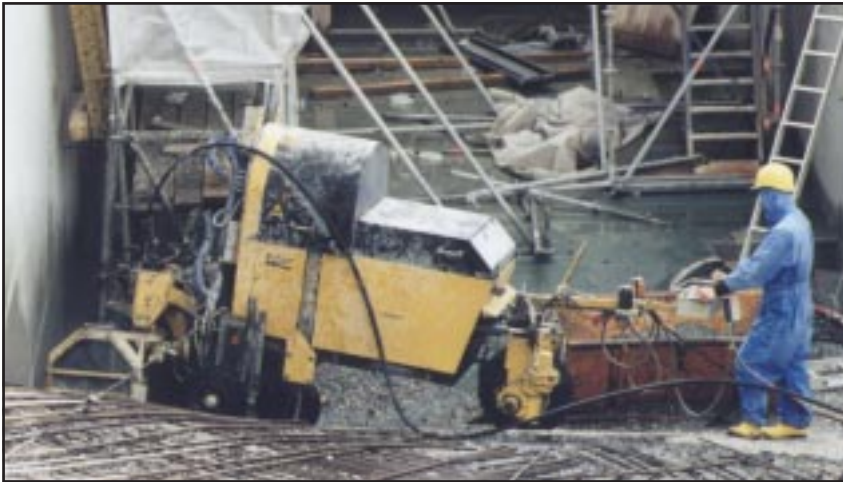
ment to achieve a good bond with the existing healthy concrete. To ensure the minimum required gap below the reinforcement was achieved the depth of concrete to be cut out was set at 120mm.

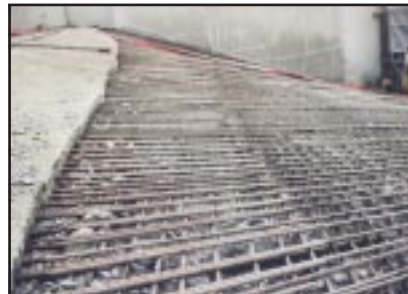
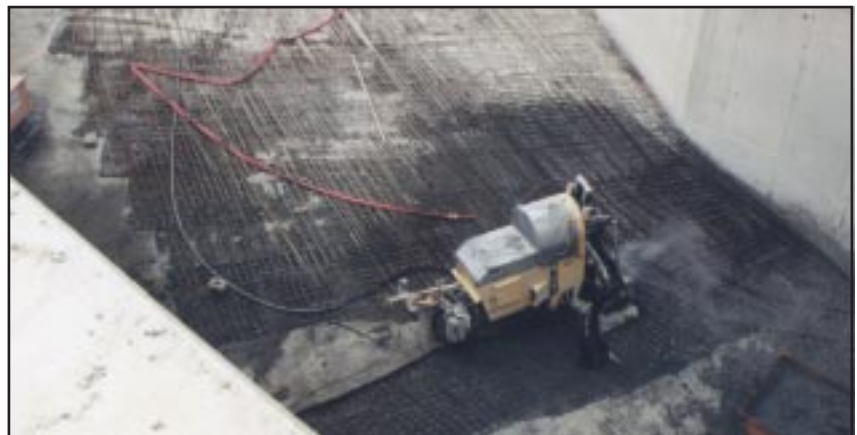
low the reinforcement using a jet of high pressure water exiting from a special nozzle at supersonic speed and forcing its way into the concrete’s porous surface. The water creates an hydraulic over pressure in the concrete which breaks away when this pressure rises above the tensile strength of the concrete. Water at a pressure of 850bar and flow of 156 litres/min was fed through a flexible hose to the Conjet Robot’s nozzle from a diesel driven, high pressure pump housed in a silenced 20ft long ISO container.

The nozzle, set at a predetermined angle of attack to the concrete, is mounted on an oscillating cassette. This is attached to a traversing cradle running back and forth along a feed beam which is mounted on the Robot’s standard arm. When the cradle reaches the end of its travel the nozzle swivels over to maintain the same angle which enables the jet to operate with a sweeping action to cut away concrete behind reinforcement. With this system Krüger Wasserhochdrucktechnik was able to set its Robot 360 to selectively remove concrete at the rate of 0.35m³/hour and expose the top layer of reinforcement. The unusual job took just two weeks before Hochtief and Bilfinger & Berger returned to place the new water resistant concrete overlay and finish the water feed channel.
